2.16.1 APPENDIX - HISTORIC ARTWORKS

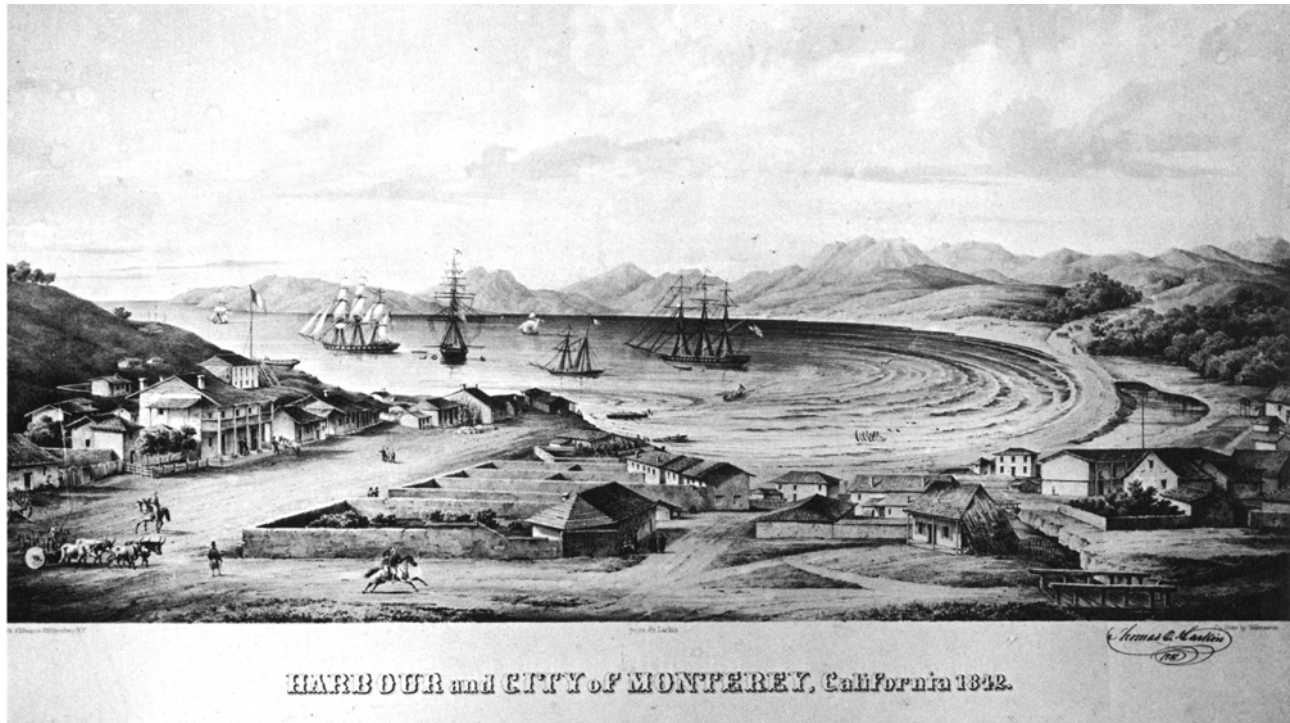
AW1 Larkin's view of Monterey in 1842 showing the "lumbered up" north and south ends of Casa Soberanes. (Van Nostrand 1968:66).

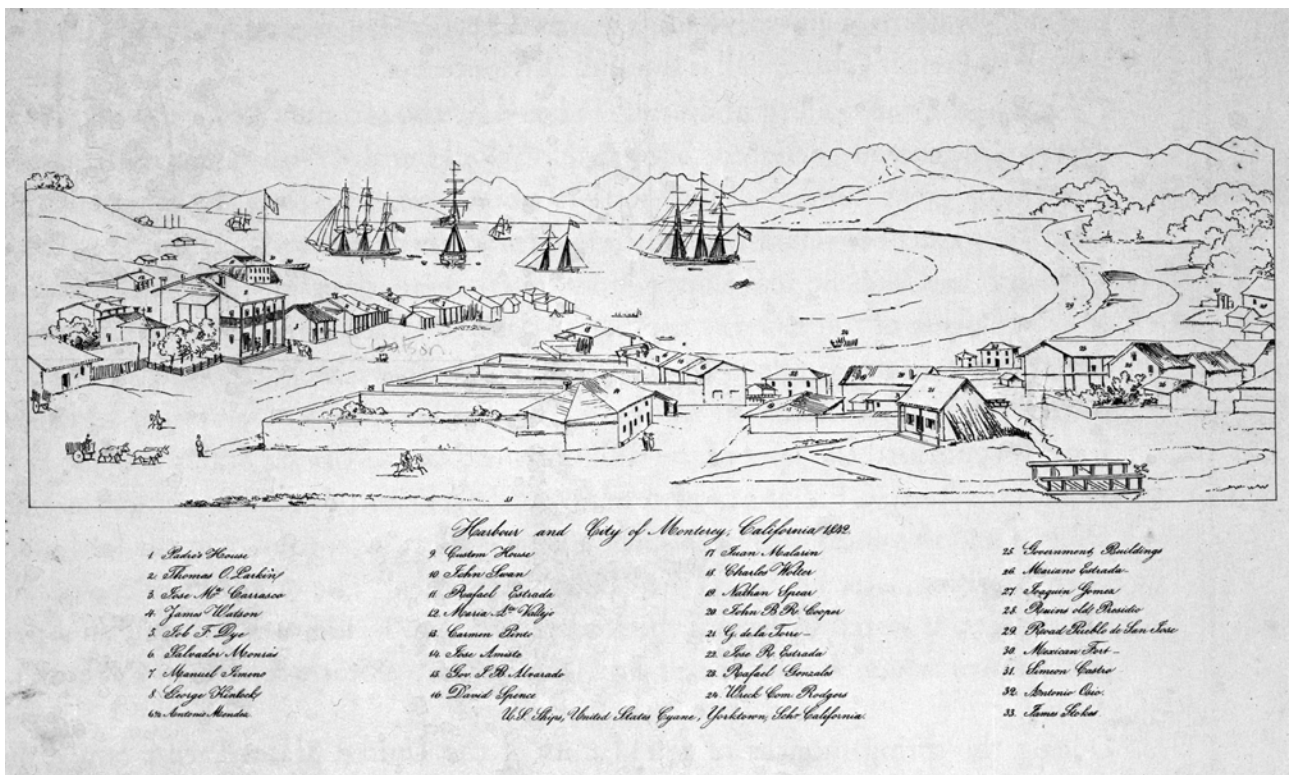
AW2 Larkin's key to the 1842 harbor view of Monterey (Van Nostrand 1968:67).

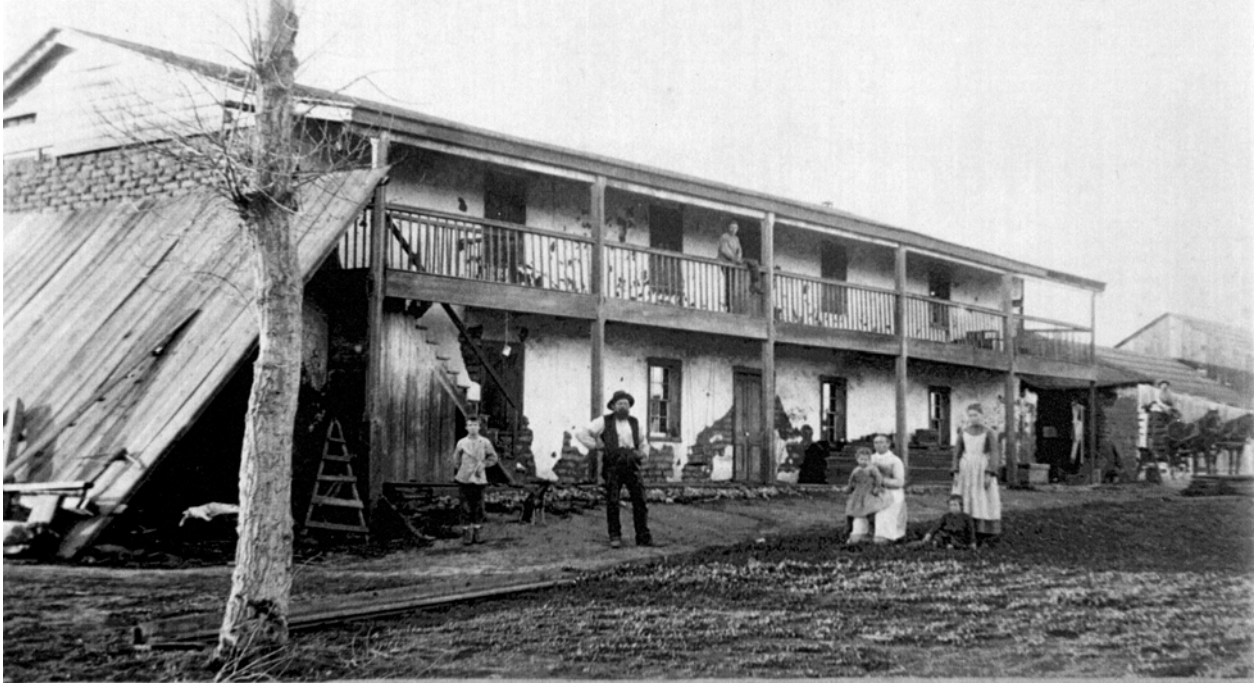
HP1 Hansen family in front of Rancho San Andres Castro Adobe “lumbered up” on the south end. Note solid shutters on front, wood floor under balcony, low roof pitch of original roof, high balcony balustrade. Barns are visible at right. Circa 1890. Myrtle Jensen Collection.

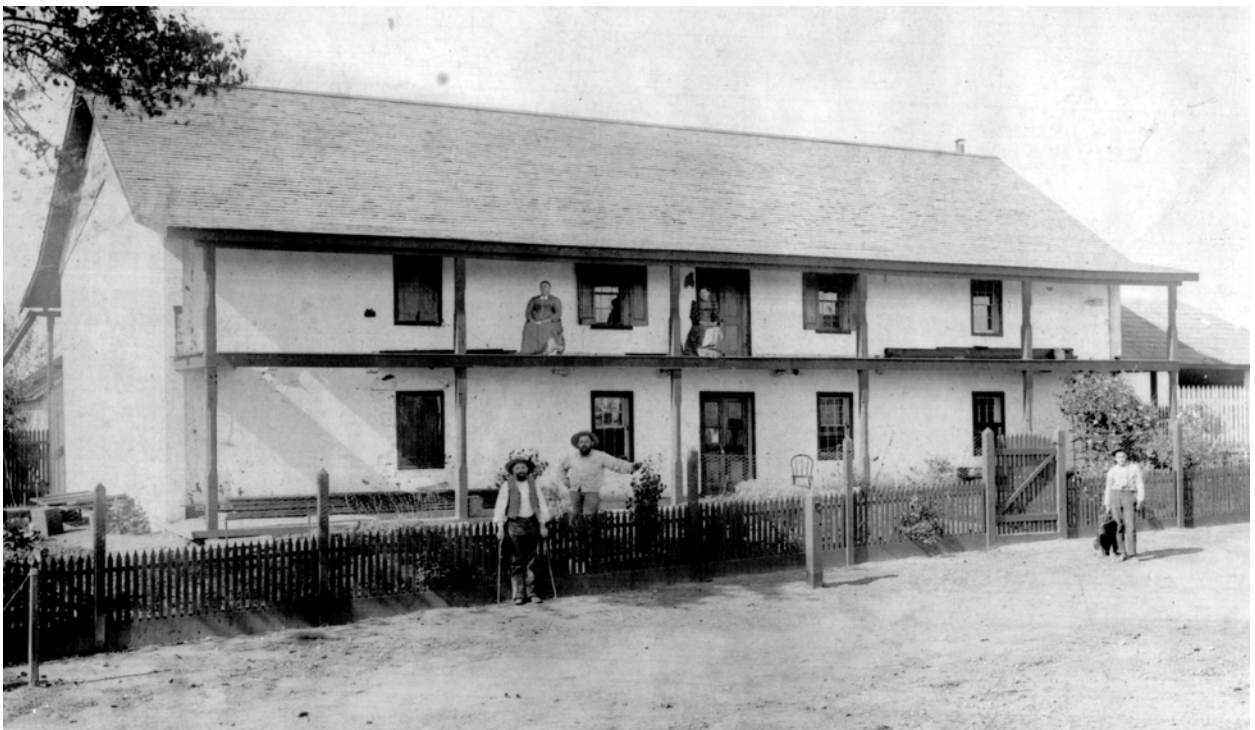
HP2 Hansen Family at Rancho San Andres Castro Adobe with picket fence, poultry yard, wood gutter at rear eave, balustrade removed, roofline and posts changed, wall anchors in place. Circa 1895. Pajaro Valley Historical Association.

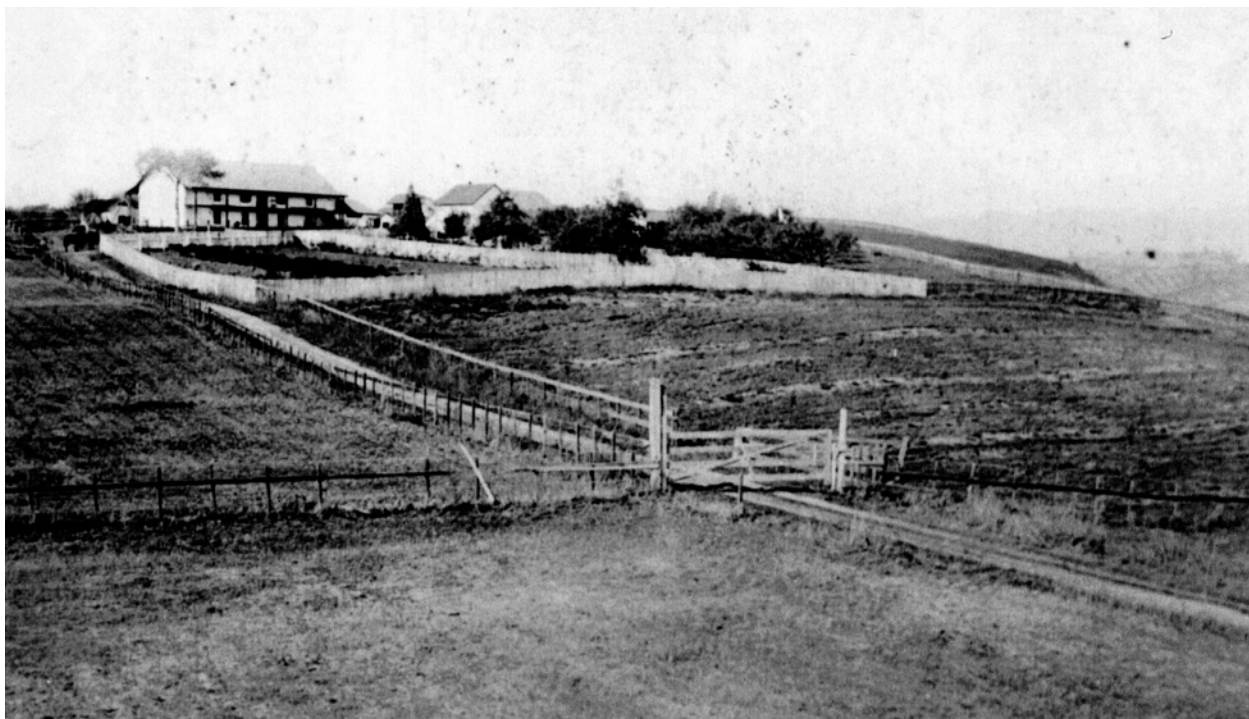
HP3 Rancho San Andres Castro Adobe with 39 acre parcel, lot #3. Note gate, fencing, fields, barns & second house. Circa 1906. Myrtle Jensen Collection.

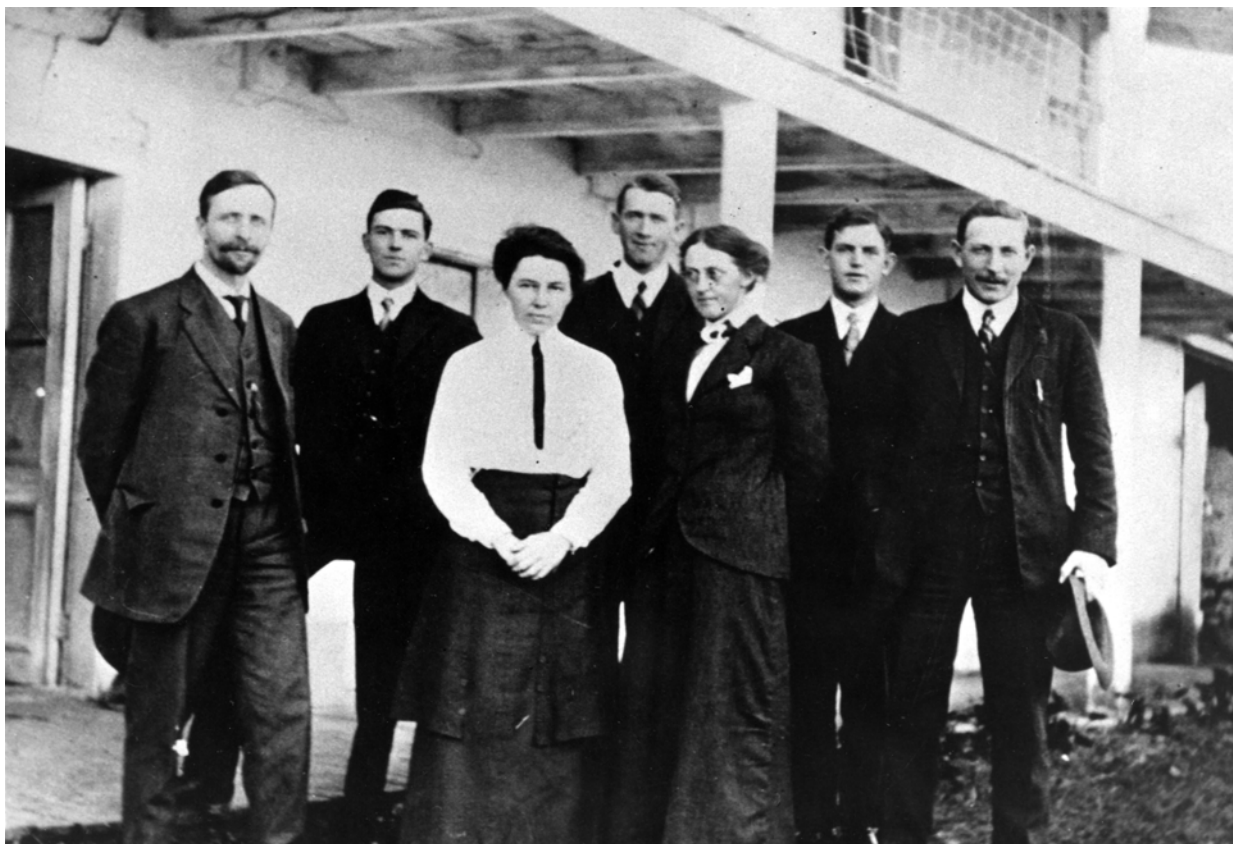
HP4 Close up of church reunion. Rancho San Andres Castro Adobe with wood floor, woven wire in place of wooden balustrade. 1915. Elizabeth Potter Collection.

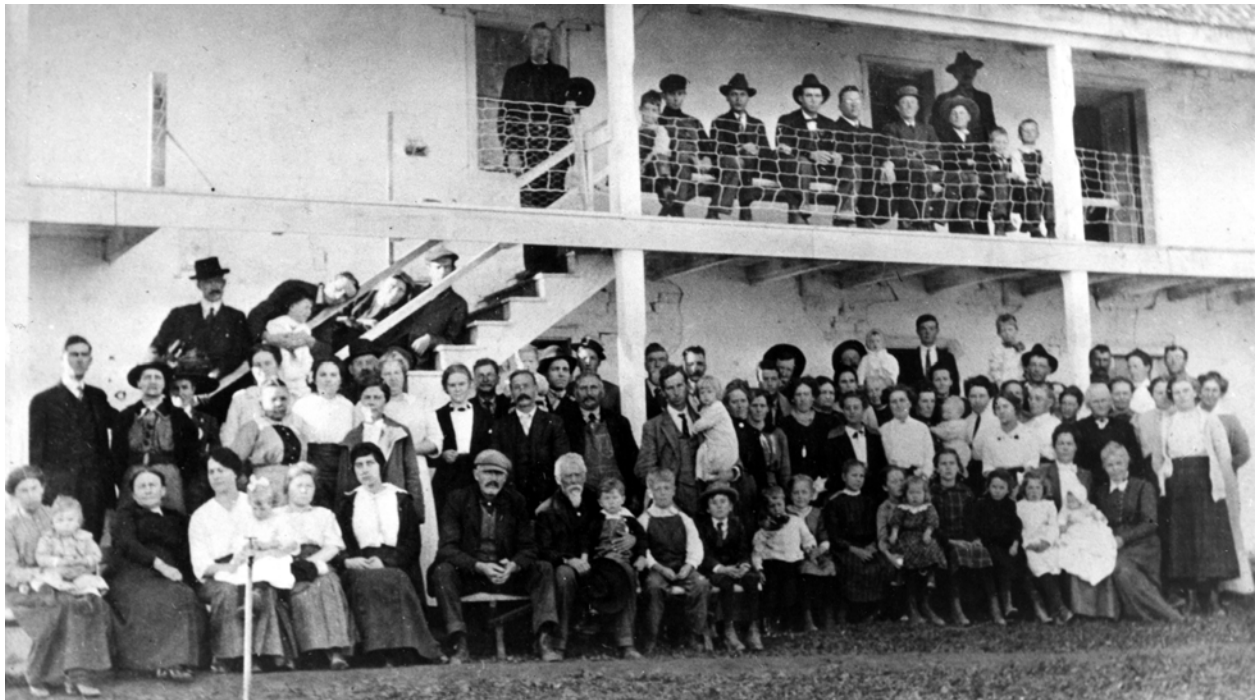
HP5 Church reunion at Rancho San Andres Castro Adobe. Government anchors in place, balcony support, woven wire mesh guard rail. Direction of stair reversed from earlier photos. 1915. Elizabeth Potter Collection.

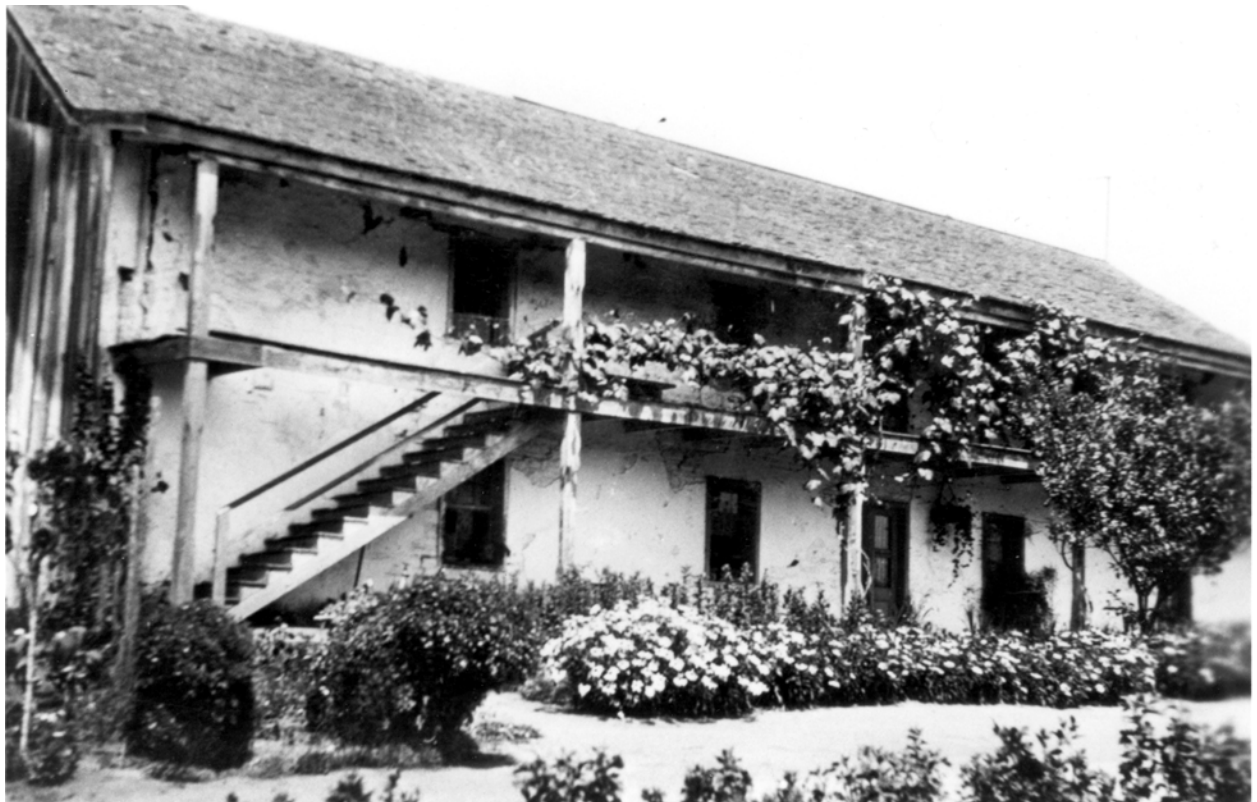
HP6 Rancho San Andres Castro Adobe with flower garden and Grapes. Wall anchors visible. Note stair run reversal. 1930s. UCSC Special Collections.

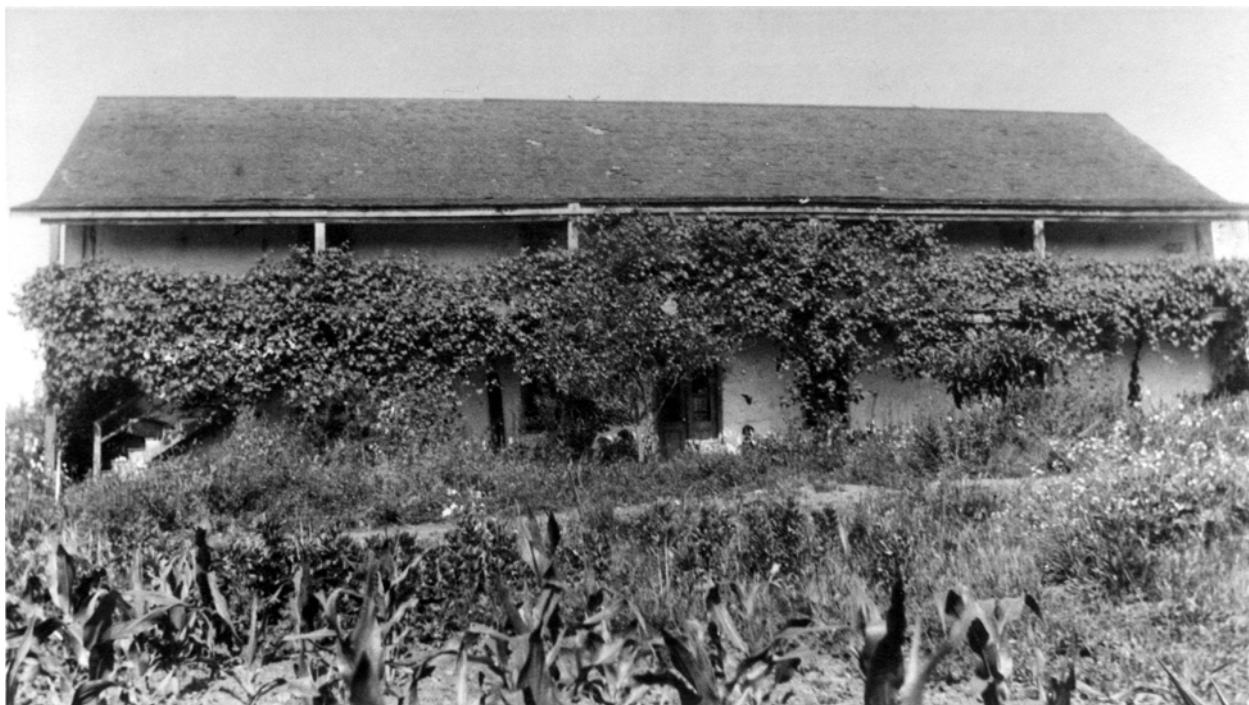
HP7 Rancho San Andres Castro Adobe with deteriorated roof, vines on balcony and corn field. 1934. Photograph Tom K. Evans. (Atkinson 1934: frontispiece). UCSC Special Collections.

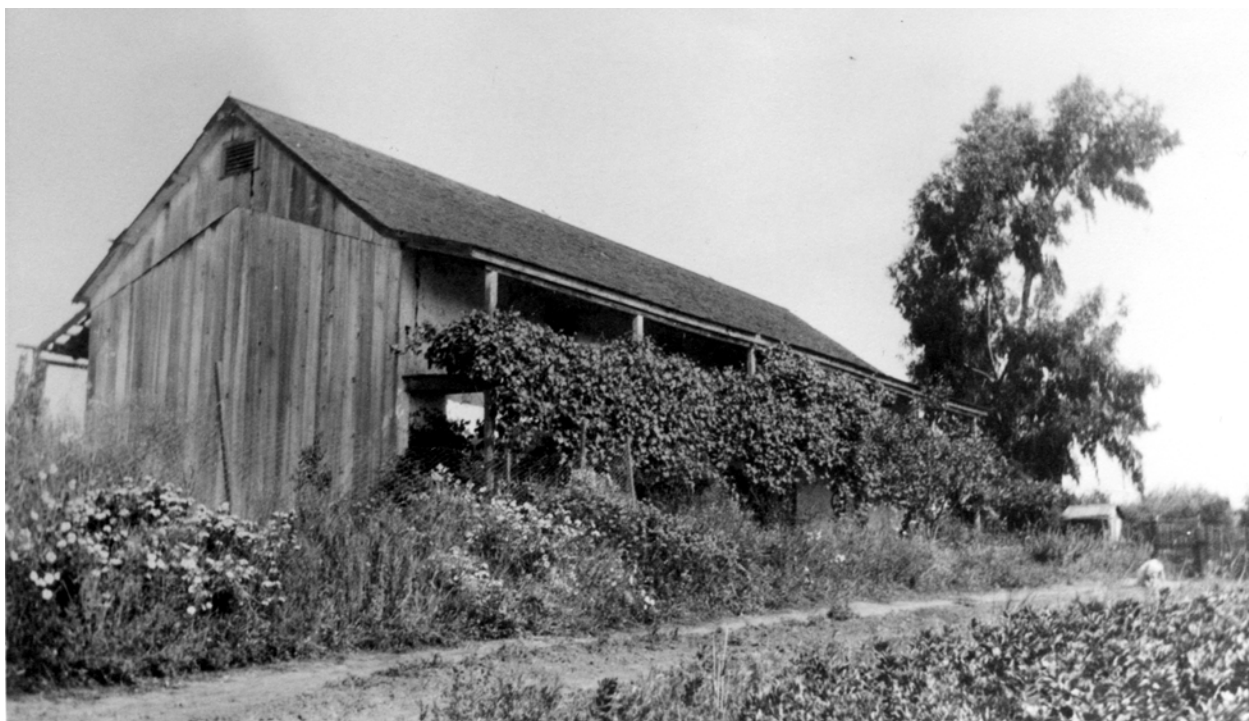
HP8 South gable end of Rancho San Andres Castro Adobe with deteriorated roof & vines on balcony. 1934. Photograph Tom K. Evans. Pajaro Valley Historical Association.

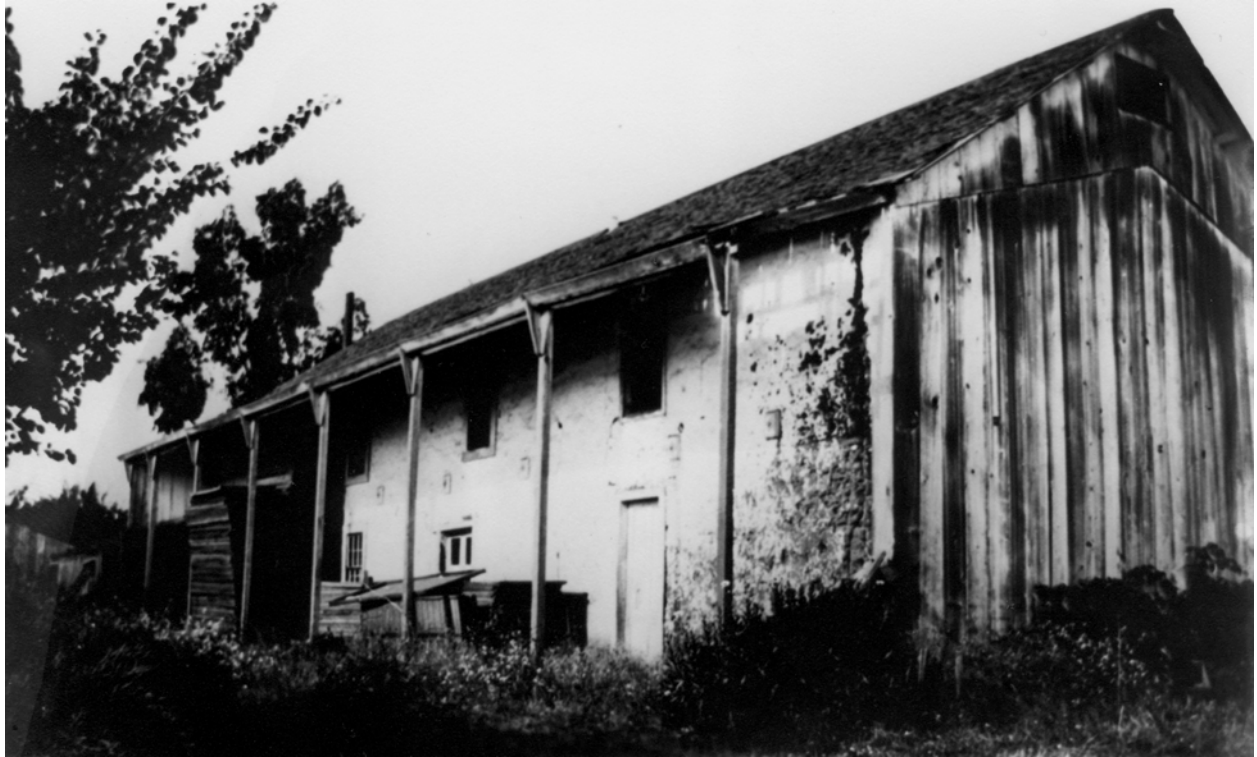
HP9 Abandoned Rancho San Andres Castro Adobe with apricot drying racks. Post 1906. Pajaro Valley Historical Association.

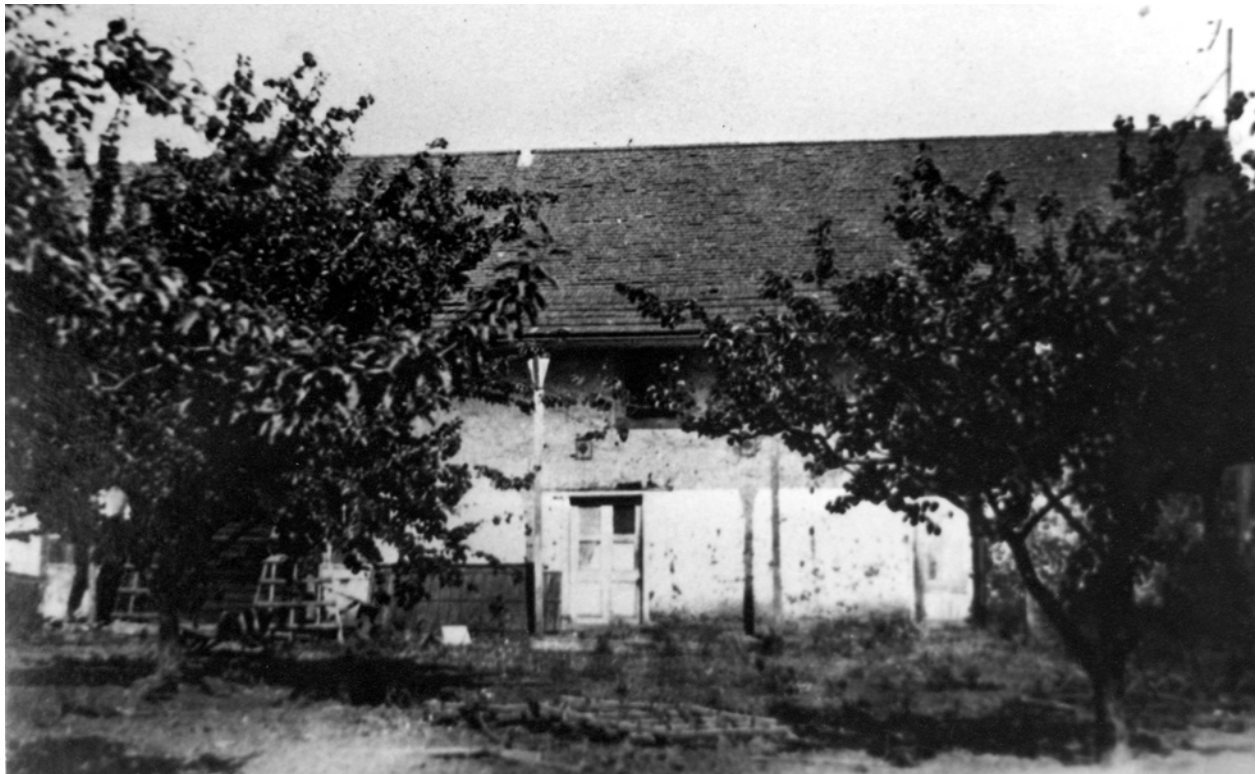
HP10 Abandoned Rancho San Andres Castro Adobe with apricot orchard and drying racks. Post 1906. Pajaro Valley Historical Association.

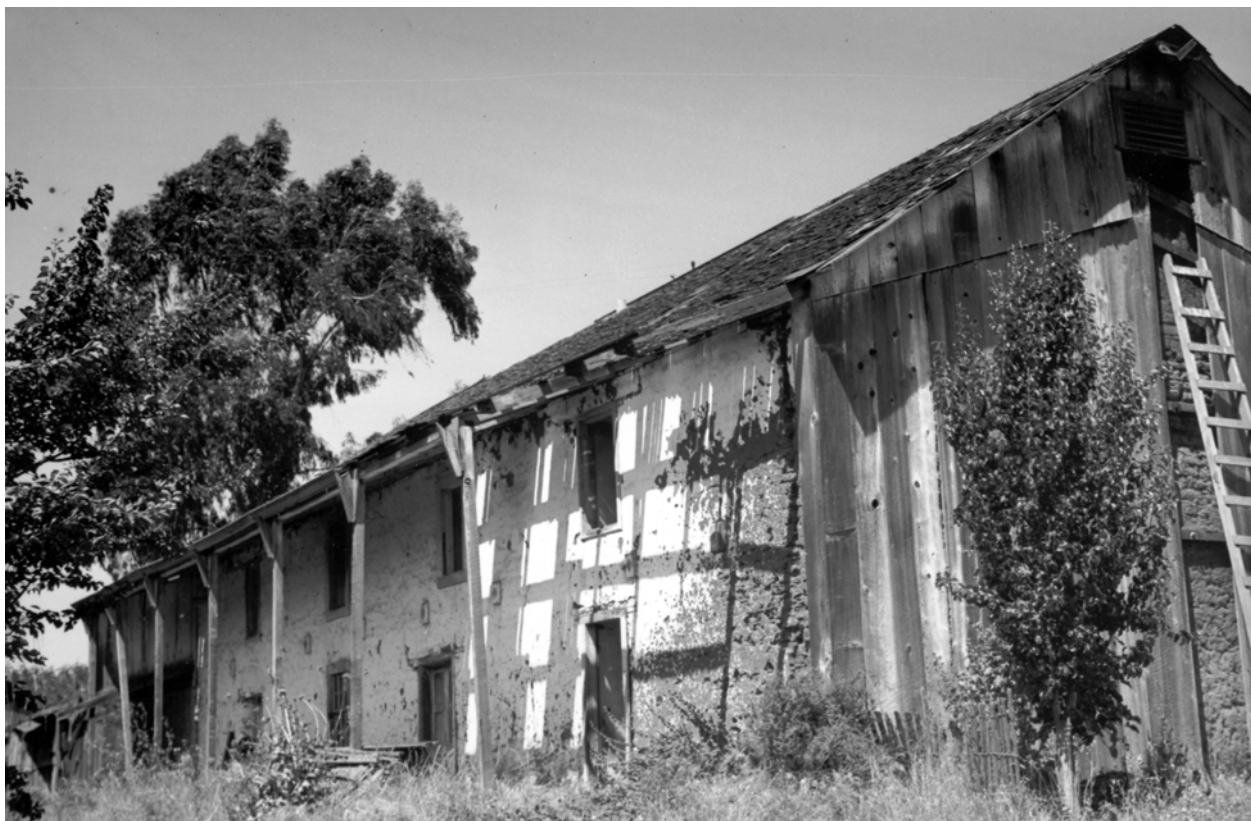
HP11 South gable end and west elevation of abandoned Rancho San Andres Castro Adobe with ladder. Circa 1937-39. Pajaro Valley Historical Association.

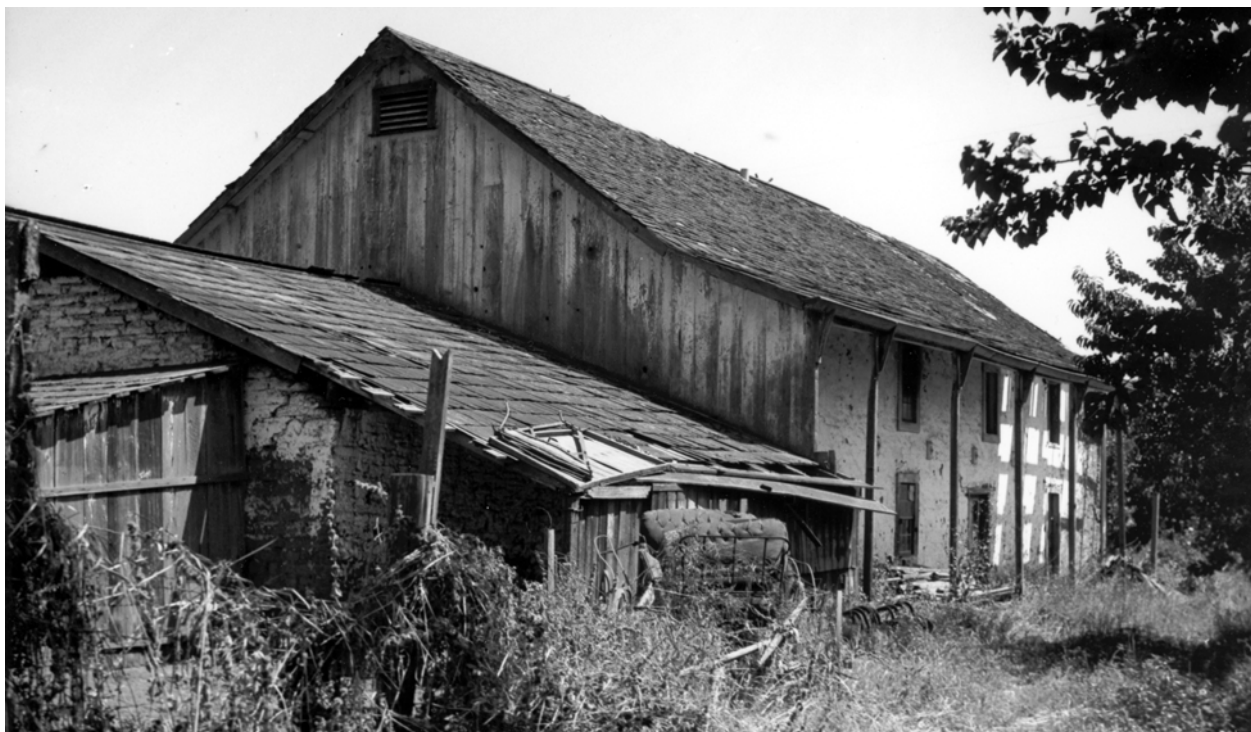
HP12 Abandoned Rancho San Andres Castro Adobe. Note sheds added to cocina. Circa 1937-39. Pajaro Valley Historical Association.

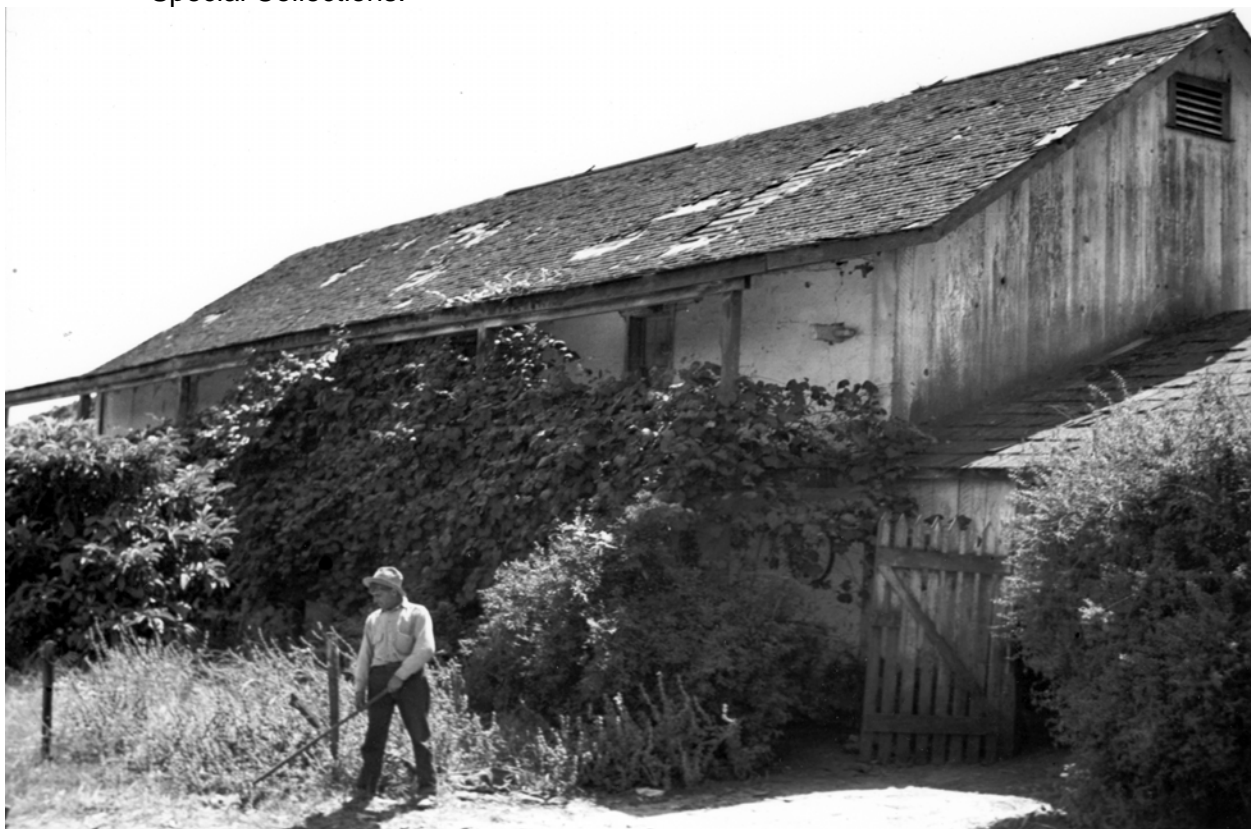
HP15 Frank Mello (according to news paper article), in front of abandoned Rancho San Andres Castro Adobe with ladder. Circa 1937-39. Pajaro Valley Historical Association.

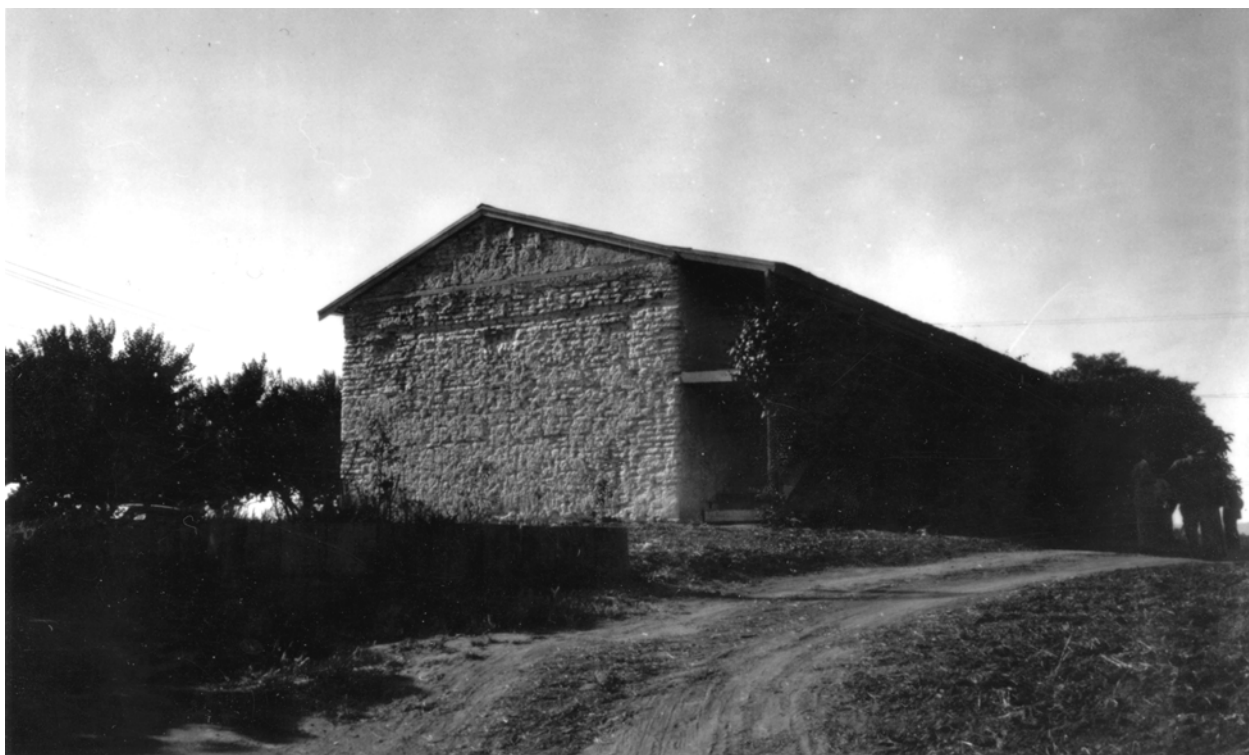
HP18 South Gable end of Rancho San Andres Castro Adobe with exposed adobe and low roof pitch. Apricot trees to the west. Circa 1941. Southwest Museum Collection.

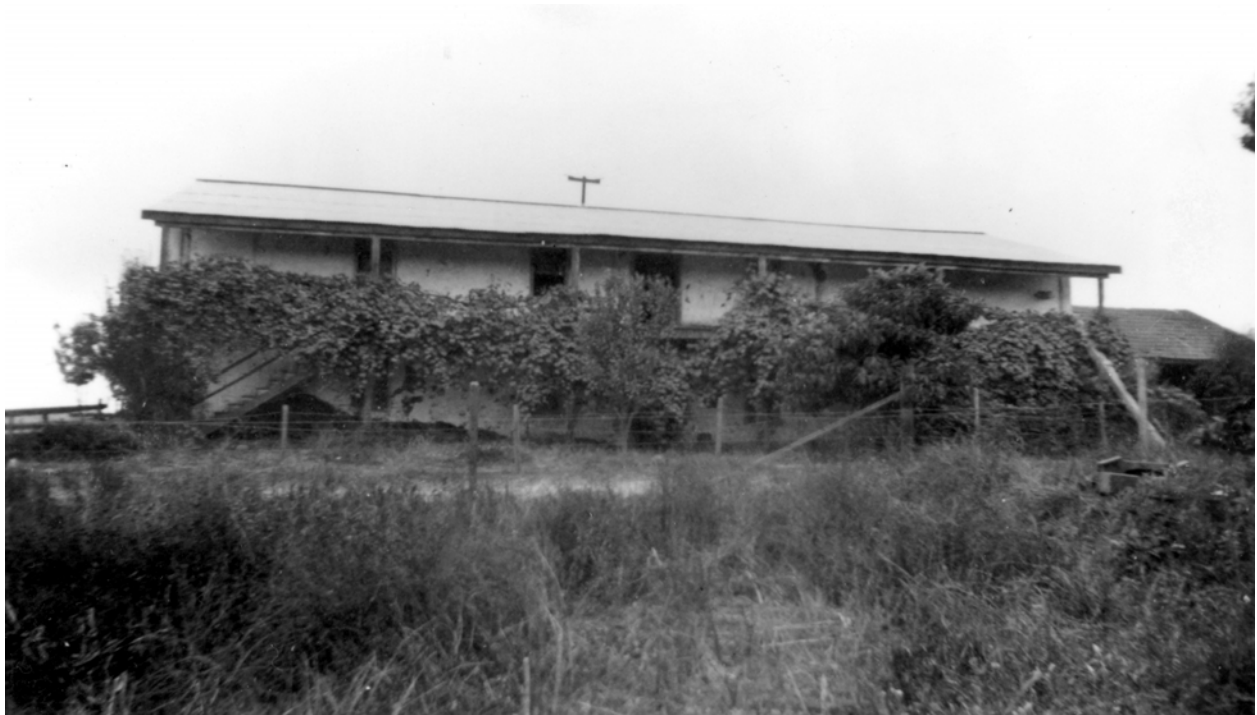
HP17 Façade of Rancho San Andres Castro Adobe with low roof pitch and Frank Mello's 1939 metal roof. Southwest Museum Collection.

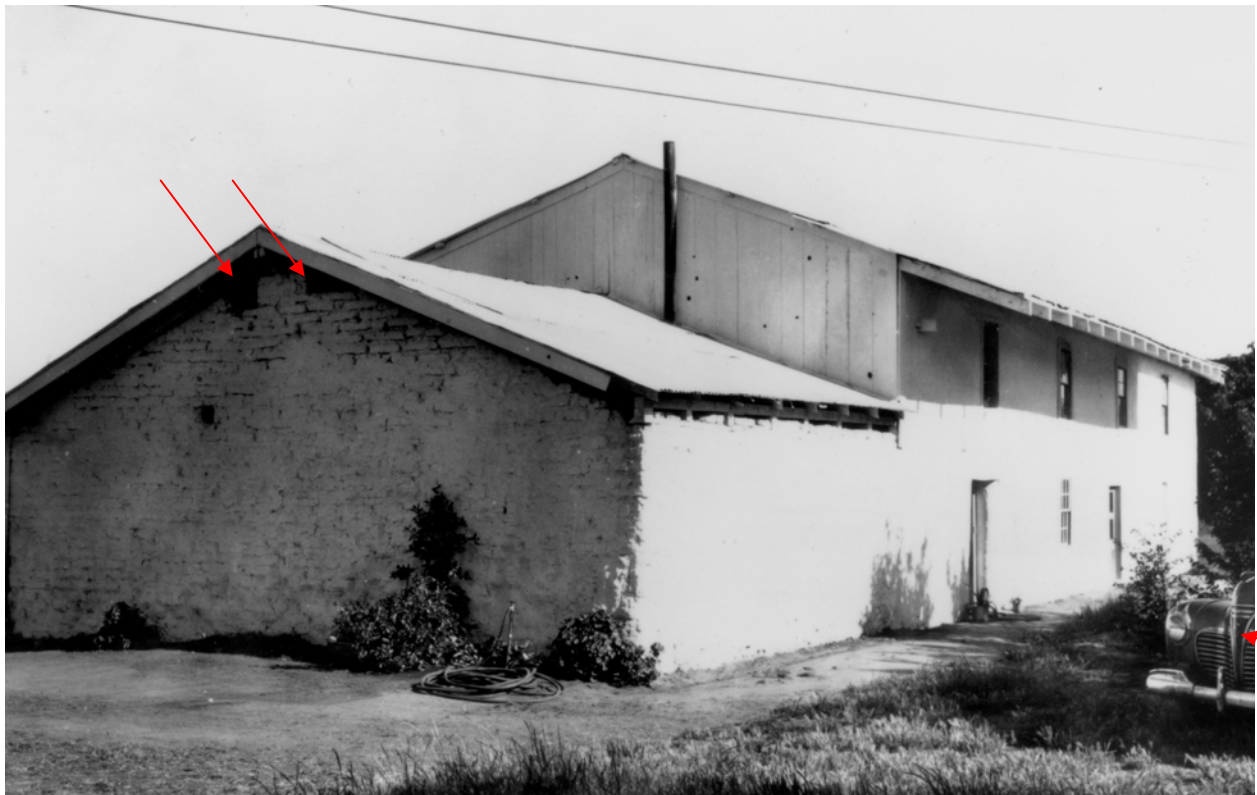
HP19 North Gable end and west elevation of Rancho San Andres Castro Adobe. Roof overhang cantilevered, no support posts. Note original vents, 1941 Plymouth at right and overhead electrical wires. Circa 1941. Southwest Museum Collection.

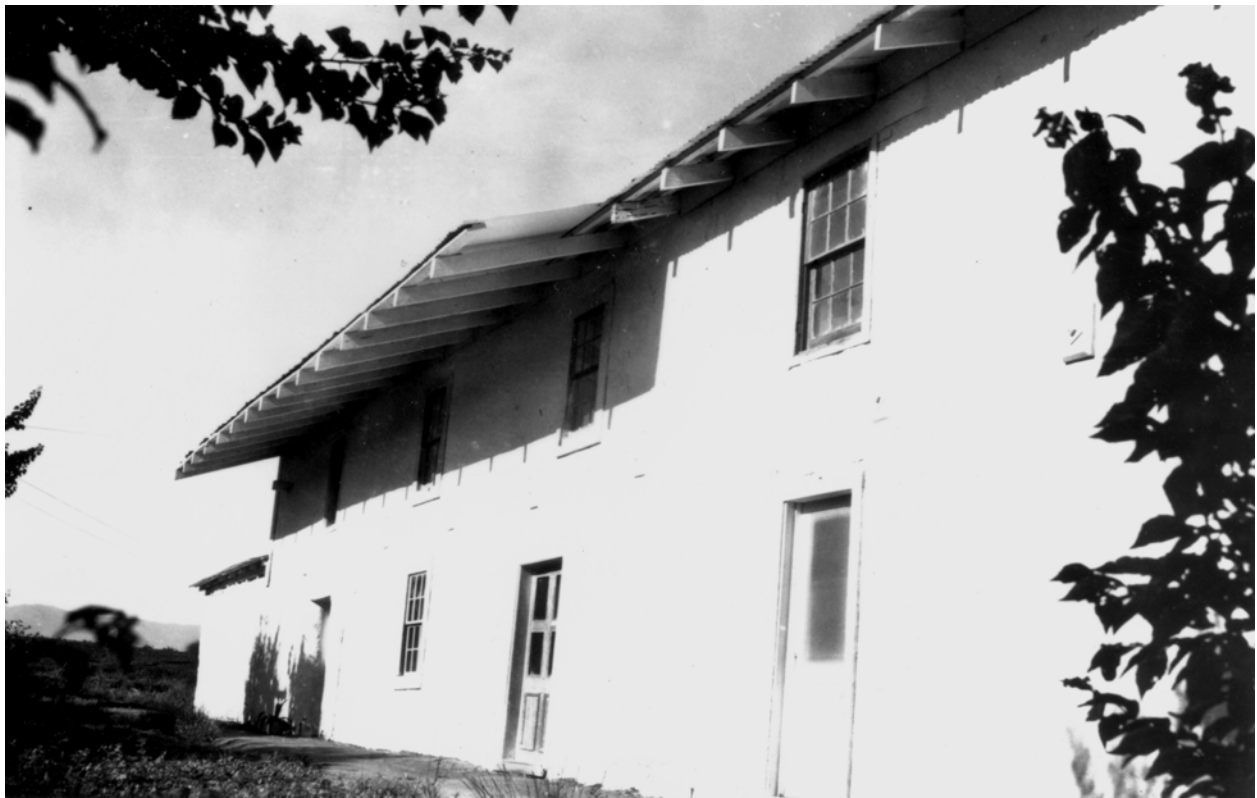
HP20 West Elevation of Rancho San Andres Castro Adobe. No roof support posts New door at south end. Circa 1941. Southwest Museum Collection.

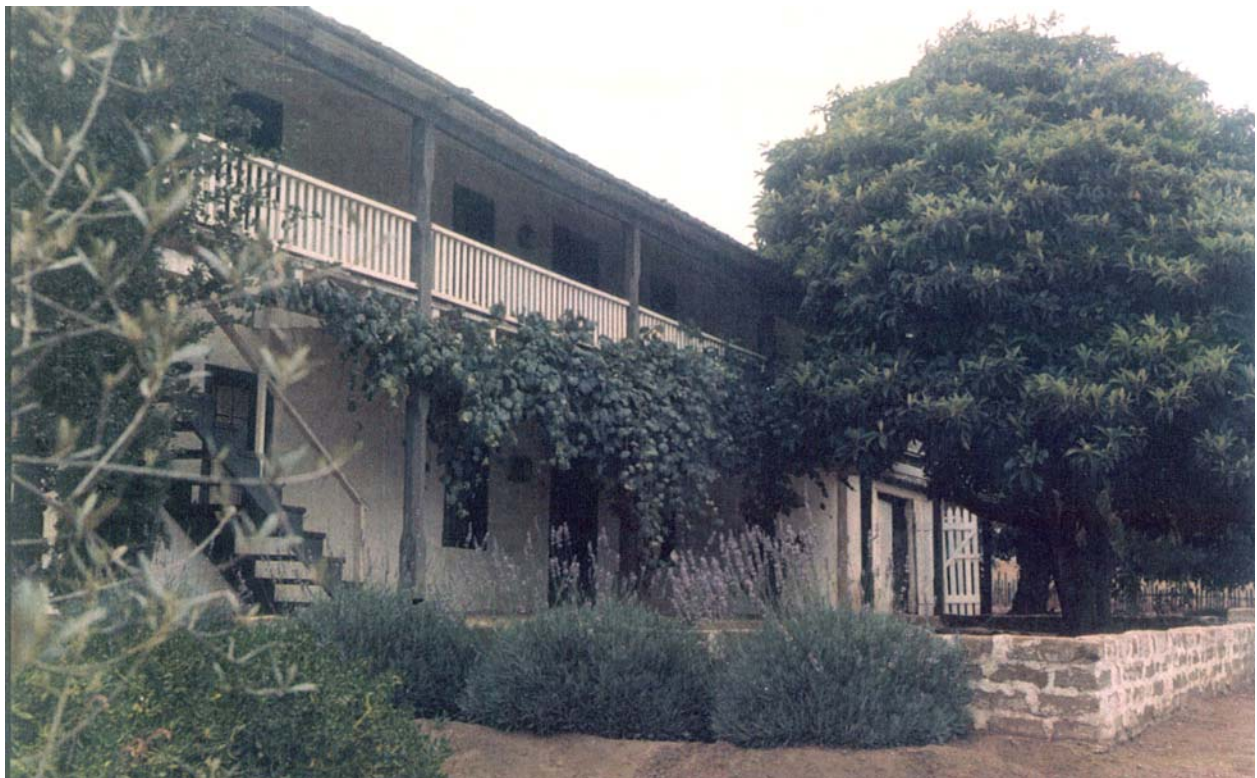
HP22 Rancho San Andres Castro Adobe Façade. Note doors, window sash and trim painted dark. Stair case reversed. Circa 1966. Elizabeth Potter Collection.

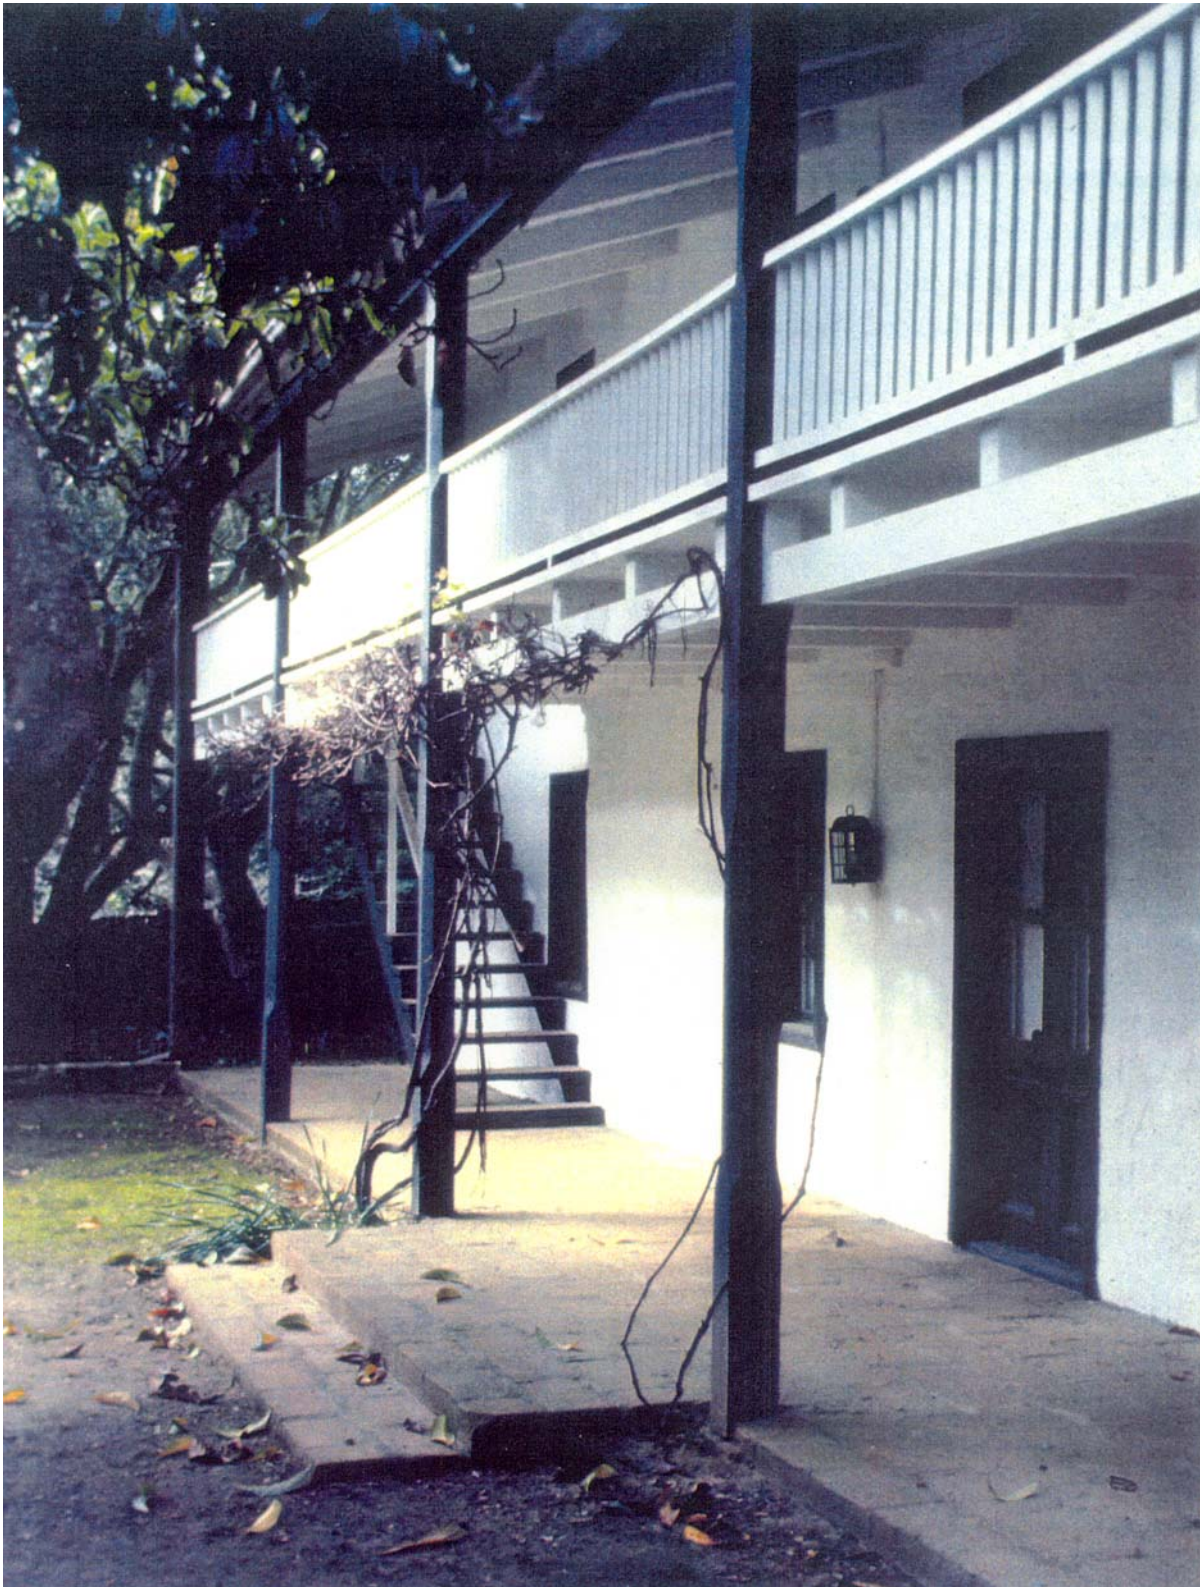
HP23 Rancho San Andres Castro Adobe façade showing balcony and staircase parallel to building façade with direction of run the same as in earliest photos. 1988. Edna E. Kimbro, photographer.
